**Flood Control Project Maintenance
Levee Inspections**

Maintenance Issue Types Only, Levee Inspection Report By Mile - Spring 2015

Reclamation District No. 0349 Sutter Island

Waterway	Bank	Unit Miles	Inspection Start/End	Inspector
Unit No. 01 Sacramento River	Right	1.59	04/14/2015 04/14/2015	Herman Phillips

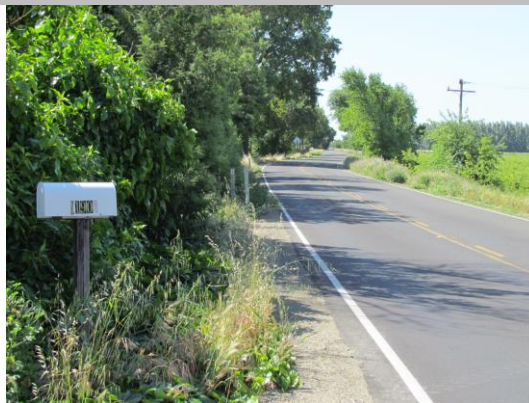
Photo 1 of 1 : SP_2015_RD0349_204_2_20150415_00130.jpg

LM Start	0.01	Rating **	U	Issue No.	2
LM End	0.13	Issue Type +	Ma	Location *	WS
Category	Earthen Levee			GPS Latitude/Longitude	
				Start	End
Item	Vegetation			38.327037 °	38.325390 °
				-121.576978 °	-121.577402 °
DWR ID	DWR_RD0349_01_f_2014_2				
Action/Comments					
Remove the wild growth other than native grasses from the levee slopes.					
Inspector Comments: This wild growth needs to be removed from the waterward levee shoulder and slope.

Looking downstream at unsatisfactory wild growth on the waterside shoulder.

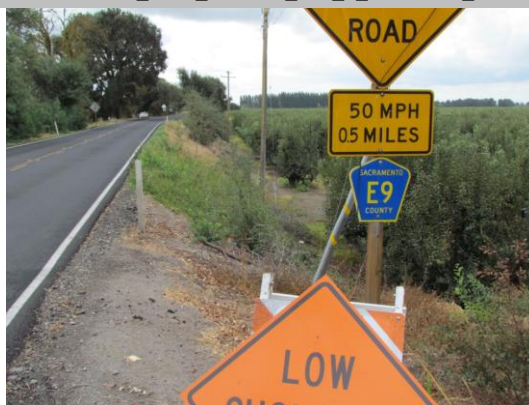
Photo 1 of 1 : SP_2015_RD0349_204_1_20150312_00001.jpg

LM Start	0.01	Rating **	U	Issue No.	1
LM End	0.97	Issue Type +	Ma	Location *	LS
Category	Earthen Levee			GPS Latitude/Longitude	
				Start	End
Item	Vegetation			38.327037 °	38.313367 °
				-121.576978 °	-121.578807 °
DWR ID	DWR_RD0349_01_f_2014_1				
Action/Comments					
Remove the wild growth other than native grasses from the levee slopes.					
Inspector Comments: Tall weeds need to be removed from levee section.

Unit 1 levee mile 0.00 landside unwanted tall weeds on levee slope.

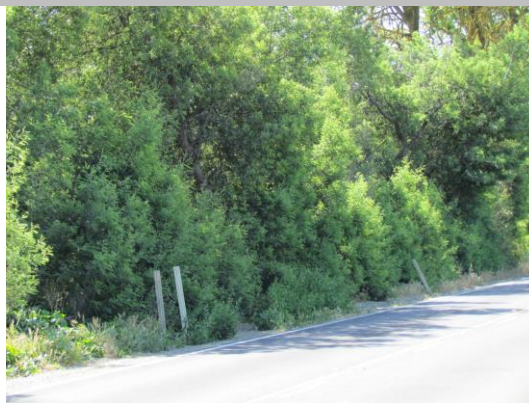
Photo 1 of 1 : SP_2015_RD0349_204_5_20150415_00131.jpg

LM Start	0.01	Rating **	U	Issue No.	5
LM End	0.06	Issue Type +	Ma	Location *	WS
Category	Earthen Levee			GPS Latitude/Longitude	
				Start	End
Item	Trim / Thin Trees			38.327037 °	38.326287 °
				-121.576980 °	-121.577076 °
DWR ID	DWR_RD0349_01_f_2014_5				
Action/Comments					
Thin trees to allow visibility of the ground and room to flood fight. Inspector Comments: Growth completely blocks visibility of levee section.

Looking downstream at the waterside. The slope is not visible through the woody tree growth.

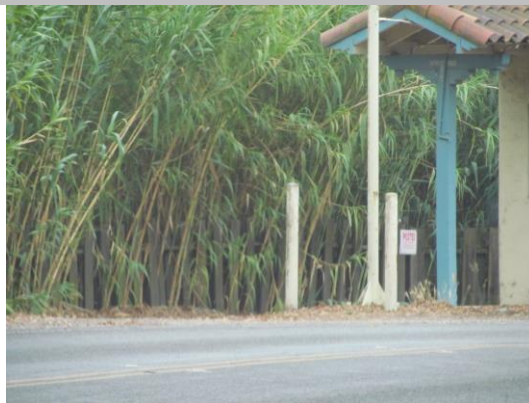
Photo 1 of 1 : SP_2015_RD0349_204_13_20150312_00005.jpg

Unwanted arundo has completely blocked the view of waterward levee slope and shoulder.

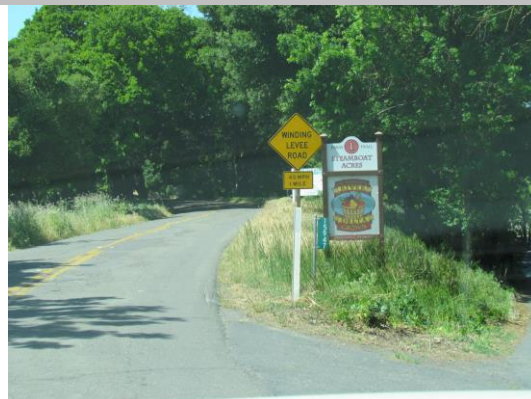
Photo 1 of 1 : SP_2015_RD0349_205_2_20150415_00298.jpg

Looking downstream at weeds present on landside slope and toe.

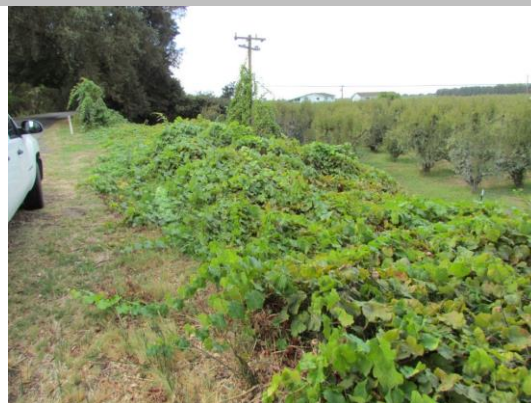
Photo 1 of 1 : SP_2015_RD0349_205_61_20150312_00021.jpg

LM Start	0.02	Rating **	U	Issue No.	61
LM End	0.10	Issue Type +	Ma	Location *	LS
Category	Earthen Levee			GPS Latitude/Longitude	
				Start	End
Item	Vegetation			38.305043 °	38.304635 °
				-121.575128 °	-121.576385 °
DWR ID	DWR_RD0349_02_f_2014_61				
Action/Comments					
Remove the wild growth other than native grasses from the levee slopes.					
Inspector Comments: This wild growth of grape vines blocks the view of the levee. The district or landowner needs to remove growth.

Unwanted wild grapes present on the landward levee slope and shoulder.

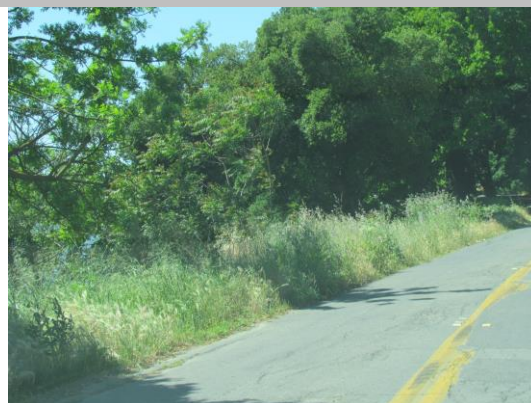
Photo 1 of 1 : SP_2015_RD0349_205_275_20150415_00299.jpg

LM Start	0.04	Rating **	U	Issue No.	275
LM End	0.09	Issue Type +	Ma	Location *	WS
Category	Earthen Levee			GPS Latitude/Longitude	
				Start	End
Item	Vegetation			38.304840 °	38.304685 °
				-121.575363 °	-121.576205 °
DWR ID	DWR_RD0349_02_s_2015_275				
Action/Comments					
Control annual grass and weeds on the levee slopes and easements. Inspector Comments: Control the tall weeds and brush on the waterside levee section.

The waterside shoulder and slope covered with unsatisfactory tall weed growth. Unit 2 RD 349.

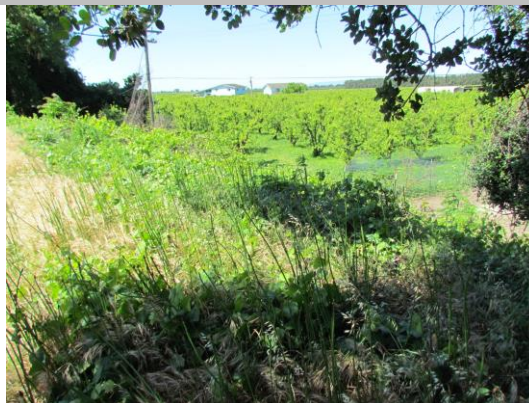
Photo 1 of 1 : SP_2015_RD0349_205_274_20150415_00300.jpg

Unsatisfactory growth of wild grapes present on the landward shoulder and slope.

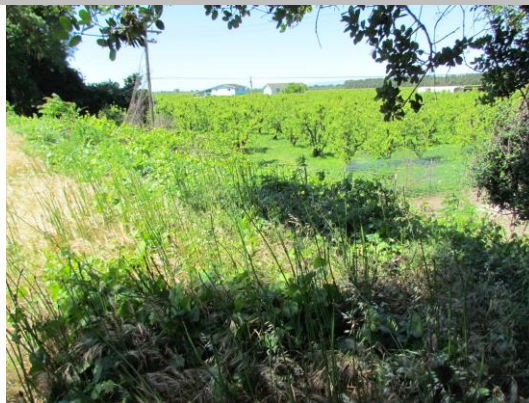
Photo 1 of 1 : SP_2015_RD0349_205_276_20150519_00309.jpg

Wild growth on the landside levee slope and shoulder.

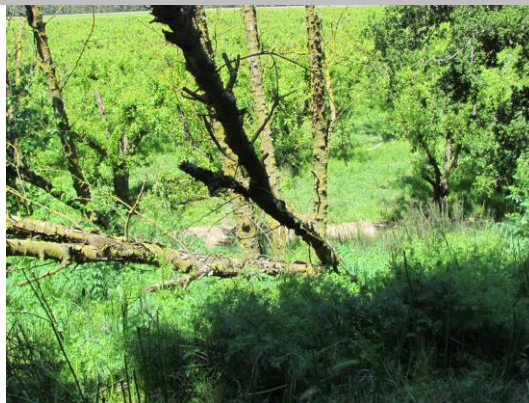
Photo 1 of 1 : SP_2015_RD0349_205_14_20150415_00301.jpg

Dead cherry trees on the landside toe and on the slope.

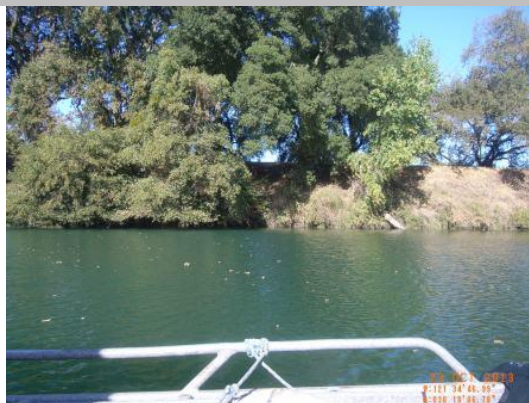
Photo 1 of 1 : SP_2015_RD0349_205_28_20150312_00015.jpg

LM Start	0.34	Rating **	M	Issue No.	28
LM End	0.39	Issue Type +	Ma	Location *	WS
Category	Supplemental			GPS Latitude/Longitude	
				Start	End
Item	USACE Erosion Survey			38.302358 °	38.301772 °
				-121.579707 °	-121.580093 °
DWR ID	DWR_RD0349_02_f_2014_28				
Action/Comments					
Inspector Comments: 2007 - Slow erosion, probably due to wave wash and fluvial erosion. Site has likely been here for awhile but was unseen due to boats parked in front. 2013: No observed changes. [2013 Site ID: STM_25-8_R]

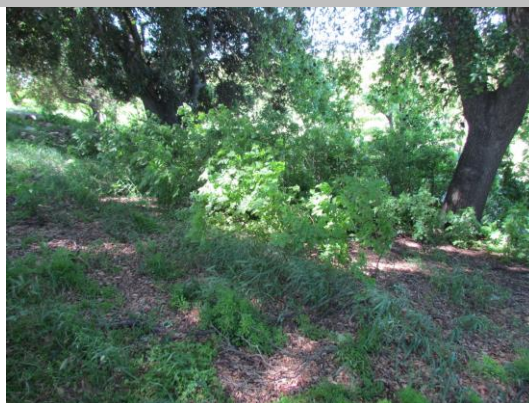
Photo 1 of 1 : SP_2015_RD0349_205_95_20150415_00302.jpg

LM Start	0.34	Rating **	U	Issue No.	95
LM End	0.34	Issue Type +	Ma	Location *	LS
Category	Earthen Levee			GPS Latitude/Longitude	
				Start	End
Item	Vegetation			38.302358 °	38.302358 °
				-121.579710 °	-121.579710 °
DWR ID	DWR_RD0349_02_s_2014_95				
Action/Comments					
Remove the wild growth other than native grasses from the levee slopes.					
Inspector Comments: Remove the unwanted wild growth from the landside slope.

Unwanted wild growth on the landside slope and toe.

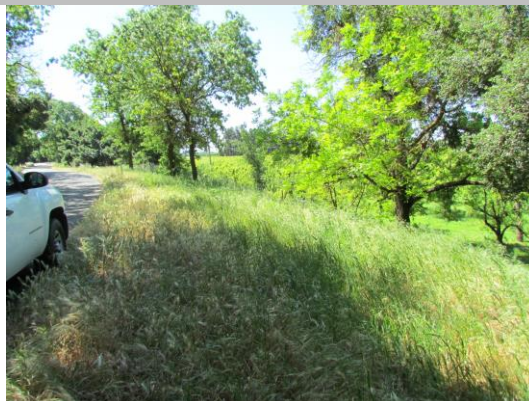
Photo 1 of 1 : SP_2015_RD0349_205_13_20150415_00303.jpg

Unwanted wild snap grasses growing on the landside levee slope.

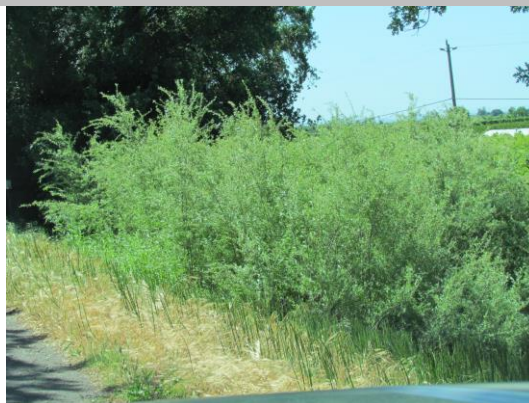
Photo 1 of 1 : SP_2015_RD0349_205_278_20150415_00304.jpg

LM Start	0.45	Rating **	U	Issue No.	278
LM End	0.46	Issue Type +	Ma	Location *	LS
Category	Earthen Levee			GPS Latitude/Longitude	
				Start	End
Item	Vegetation			38.301037 °	38.300872 °
				-121.580675 °	-121.580718 °
DWR ID	DWR_RD0349_02_s_2015_278				
Action/Comments					
Remove the wild growth other than native grasses from the levee slopes.					
Inspector Comments: Young willow trees on landside levee slope need to be removed.

Unwanted growth of wild young willow trees present on the slope and toe landward.

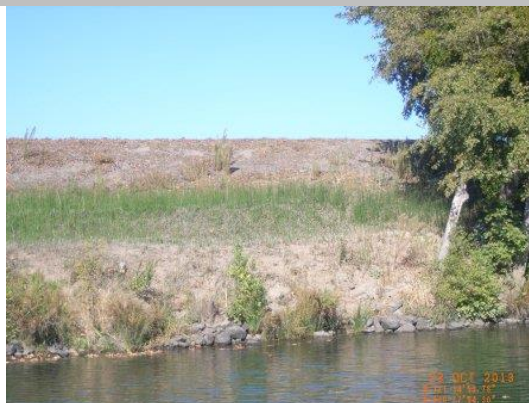
Photo 1 of 1 : SP_2015_RD0349_205_27_20150312_00014.jpg

LM Start	0.60	Rating **	M	Issue No.	27
LM End	0.72	Issue Type +	Ma	Location *	WS
Category	Supplemental			GPS Latitude/Longitude	
				Start	End
Item	USACE Erosion Survey			38.298897 °	38.297384 °
				-121.581571 °	-121.582176 °
DWR ID	DWR_RD0349_02_f_2014_27				
Action/Comments					
Inspector Comments: 2010 - Small maintenance, erosion into the toe. 2011 - Minor new erosion at toe. 2013: No observed changes. [2013 Site ID: STM_25-5_R]

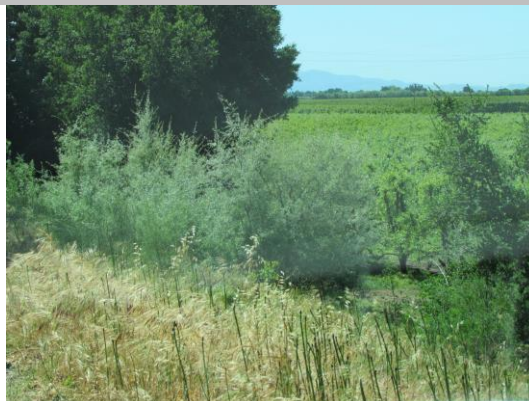
Photo 1 of 1 : SP_2015_RD0349_205_279_20150415_00305.jpg

Unwanted wild growth of willow trees on the landside slope and toe of the levee section.

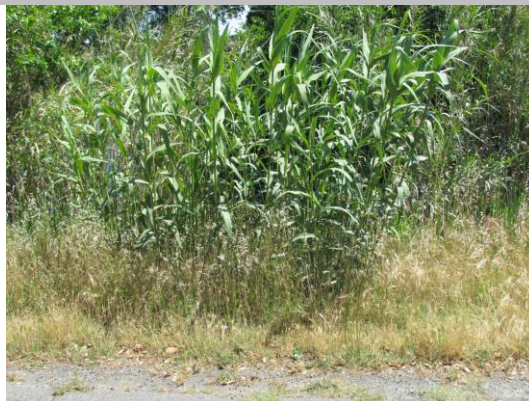
Photo 1 of 1 : SP_2015_RD0349_205_63_20150415_00306.jpg

Unwanted growth of arundo growing on the waterside slope.

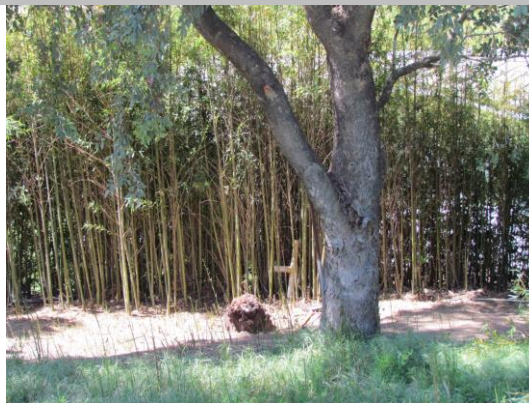
Photo 1 of 1 : SP_2015_RD0349_205_78_20150415_00307.jpg

Unwanted growth of arundo on the landward levee section and levee toe.

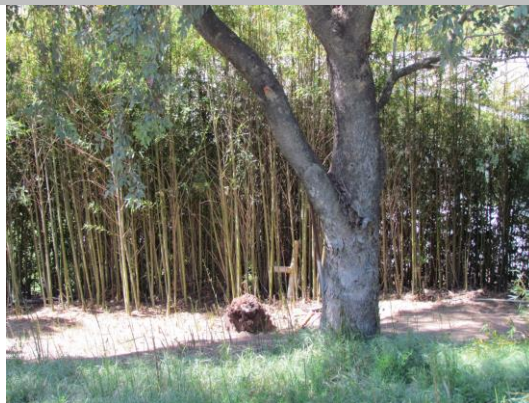
Photo 1 of 1 : SP_2015_RD0349_205_77_20150519_00310.jpg

LM Start	1.00	Rating **	U	Issue No.	77
LM End	1.01	Issue Type +	Ma	Location *	LS
Category	Earthen Levee			GPS Latitude/Longitude	
				Start	End
Item	Vegetation			38.293382 °	38.293298 °
				-121.583533 °	-121.583595 °
DWR ID	DWR_RD0349_02_s_2015_77				
Action/Comments					
Remove the wild growth other than native grasses from the levee slopes.					
Inspector Comments: This arundo at the toe of the landside levee slope should be removed

Mature growth of arundo on the levee toe, the landowner has been slowly removing some of this growth.

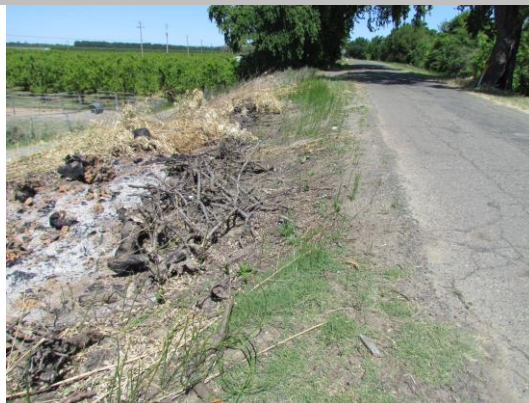
Photo 1 of 1 : SP_2015_RD0349_205_79_20150519_00311.jpg

LM Start	1.06	Rating **	U	Issue No.	79
LM End	1.07	Issue Type +	Ma	Location *	LS
Category	Earthen Levee			GPS Latitude/Longitude	
				Start	End
Item	Slope Stability			38.292623 °	38.292460 °
				-121.583847 °	-121.583872 °
DWR ID	DWR_RD0349_02_s_2014_79				
Action/Comments					
Repair slope instability. Inspector Comments: The erosion was covered over by the piles of tree trimmings, now that they are being burned the erosion can be seen.

The erosion was covered up from view by the burned brush pile.

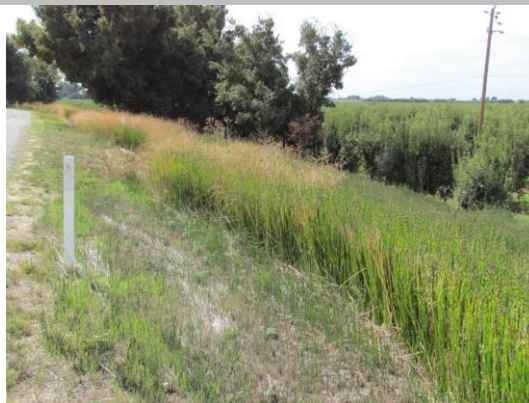
Photo 1 of 1 : SP_2015_RD0349_205_64_20150312_00023.jpg

At this location snap grasses have completely blocked the view of the landward levee slope.

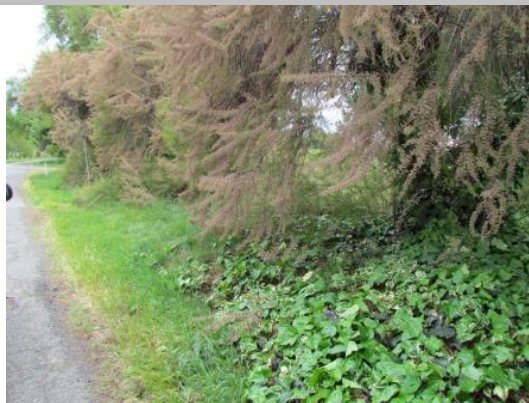
Photo 1 of 1 : SP_2015_RD0349_205_83_20150312_00032.jpg

Woody tree growth blocks view of landside levee section.

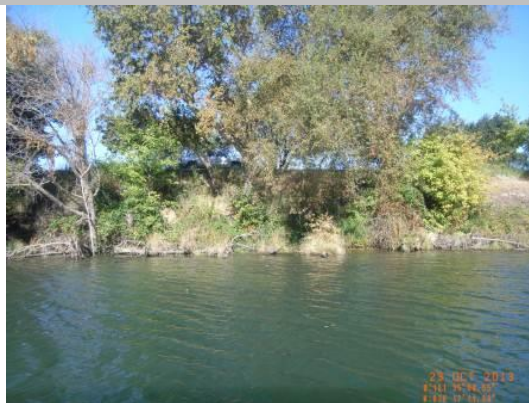
Photo 1 of 1 : SP_2015_RD0349_205_26_20150312_00013.jpg

LM Start	1.33	Rating **	U	Issue No.	26
LM End	1.49	Issue Type +	Ma	Location *	WS
Category	Supplemental			GPS Latitude/Longitude	
				Start	End
Item	USACE Erosion Survey			38.288727 °	38.286475 °
				-121.583823 °	-121.585026 °
DWR ID	DWR_RD0349_02_f_2014_26				
Action/Comments					
Inspector Comments: 1997 - Erosion of very sandy levee behind large stand of riparian vegetation on top right bank. Dry ravel of sand. 1999 - Quarry waste rock was dumped down the levee slope; poor repair job; still eroding in places. Eroding at midslope off fabric. 2005 - Length revised, only the middle 150 - 200 ft are eroding. 2006 - Some rock/small material dumped down the bank but it is slowly unraveling. Upstream end is unraveling faster. Steep slope with poor gradation so fines are washing out. 2010 - Lots of overhanging trees and erosion pockets. 2011 - This site is upgraded to CRITICAL. Near vertical bank at the downstream end. New erosion at various locations throughout the site. 2013: No observed changes. [2013 Site ID: STM 24-7 R]

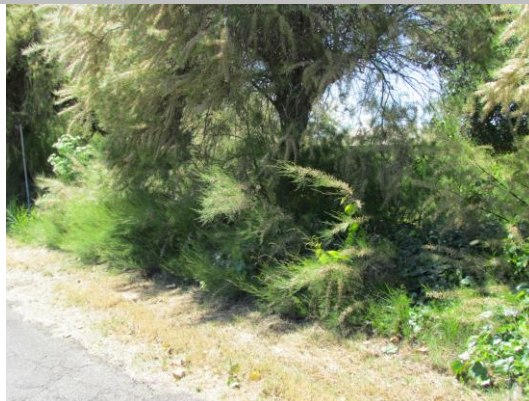
Photo 1 of 1 : SP_2015_RD0349_205_9_20150519_00308.jpg

Wild tree growth blocks view of landside levee slope.

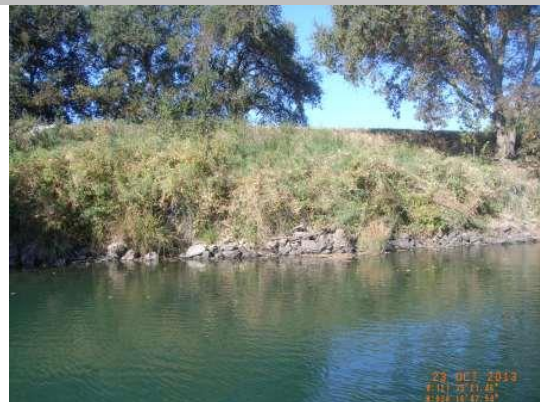
Photo 1 of 1 : SP_2015_RD0349_205_23_20150312_00012.jpg

LM Start	2.04	Rating **	M	Issue No.	23
LM End	2.05	Issue Type +	Ma	Location *	WS
Category	Supplemental			GPS Latitude/Longitude	
				Start	End
Item	USACE Erosion Survey			38.280069 °	38.279919 °
				-121.589443 °	-121.589438 °
DWR ID	DWR_RD0349_02_f_2014_23				
Action/Comments					
Inspector Comments: 2011 - Small scallop caused by erosion and wave wash. 2013: No observed changes. [2013 Site ID: STM_24-1_R]

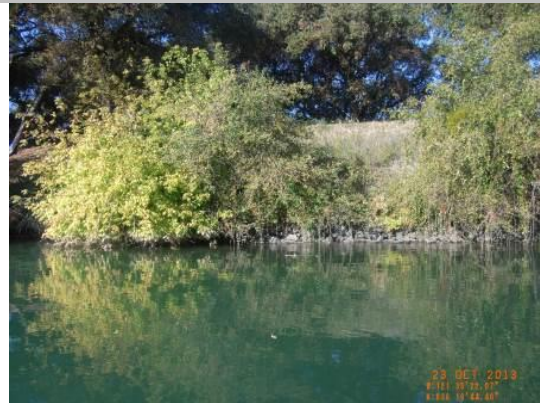
Photo 1 of 1 : SP_2015_RD0349_205_21_20150312_00011.jpg

LM Start	2.11	Rating **	M	Issue No.	21
LM End	2.14	Issue Type +	Ma	Location *	WS
Category	Supplemental			GPS Latitude/Longitude	
				Start	End
Item	USACE Erosion Survey			38.279017 °	38.278597 °
				-121.589615 °	-121.589854 °
DWR ID	DWR_RD0349_02_f_2014_21				
Action/Comments					
Inspector Comments: 1997 - Top right bank has retreated into the levee. Site is between two rock sites. 1999 - Downstream half of the reach repaired with rock. 2000 - Trees leaning into the water. 2010 - Site appears worse. 2011 - New erosion at the toe. 2013: Short vertical sections observed at upstream end. [2013 Site ID: STM_23-9_R]

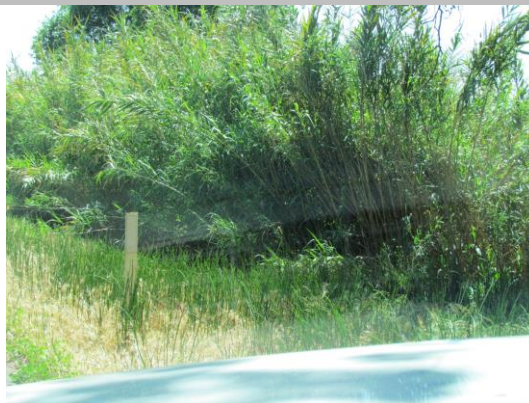
Photo 1 of 1 : SP_2015_RD0349_205_94_20150519_00313.jpg

Arundo on the landside blocking view of the slope.

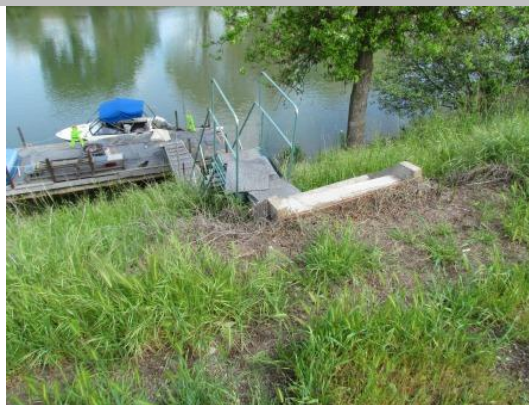
Photo 1 of 2 : SP_2015_RD0349_205_1_20150312_00001.jpg

Unsatisfactory steps placed on waterward slope and toe. No new photo.

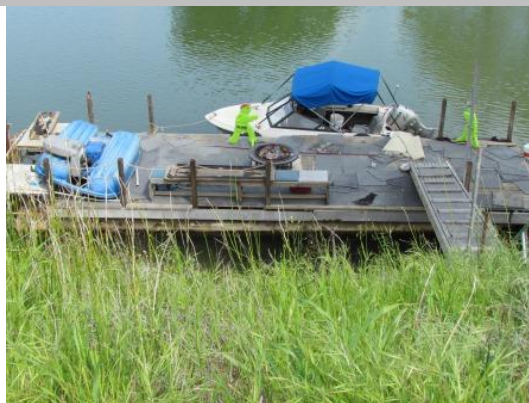
Photo 2 of 2 : SP_2015_RD0349_205_1_20150312_00002.jpg

Unauthorized boat dock at end of steps. No new photo.

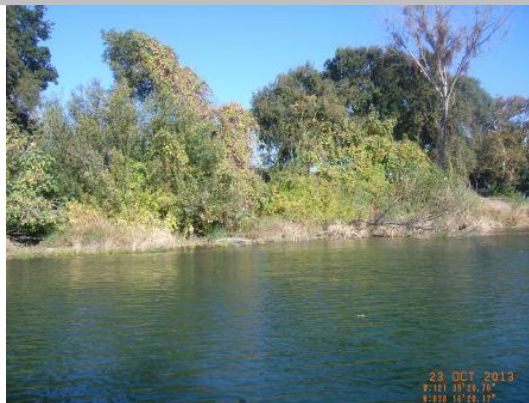
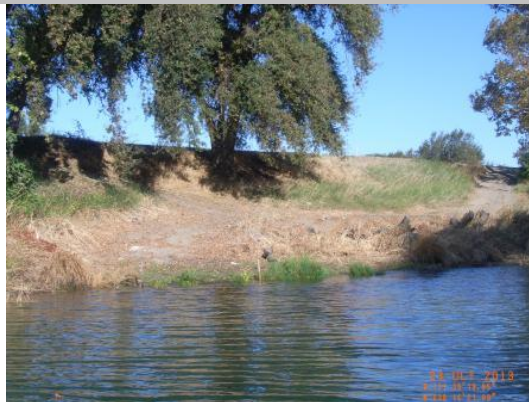
LM Start	2.56	Rating **	M	Issue No.	19
LM End	2.69	Issue Type +	Ma	Location *	WS
Category	Supplemental			GPS Latitude/Longitude	
				Start	End
Item	USACE Erosion Survey			38.273854 °	38.271998 °
				-121.588745 °	-121.589424 °
DWR ID	DWR_RD0349_02_f_2014_19				
Action/Comments					
Inspector Comments: 2011 - Toe scour at the tidal zone. 2013: No observed changes. [2013 Site ID: STM_23-6_R]

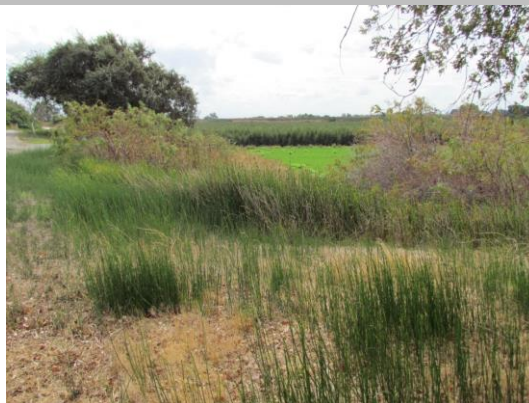
Photo 1 of 1 : SP_2015_RD0349_205_91_20150312_00034.jpg

Unsatisfactory wild growth wild weeds and wild roses present on the landward levee section.

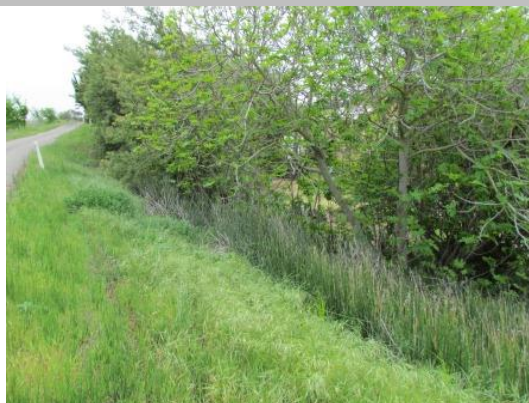
Photo 1 of 1 : SP_2015_RD0349_205_92_20150312_00035.jpg

Woody tree growth blocking view of landward levee section.

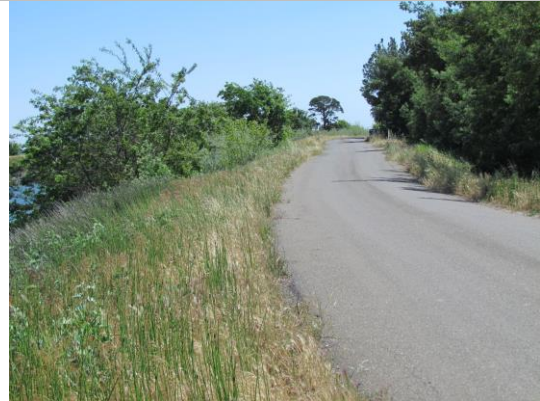
Photo 1 of 1 : SP_2015_RD0349_205_66_20150519_00314.jpg

Wild growth of tall weeds on the waterside slope.

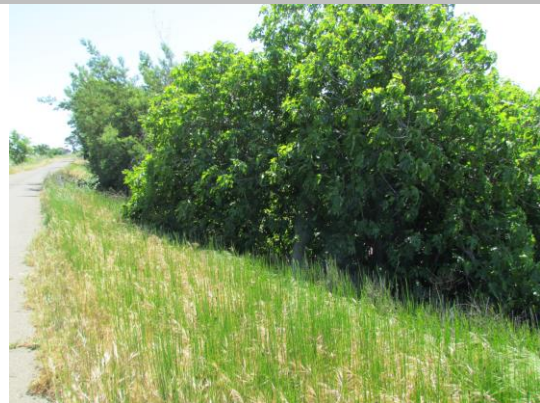
Photo 1 of 1 : SP_2015_RD0349_205_53_20150519_00315.jpg

Woody tree growth blocks the view of the shoulder and slope.

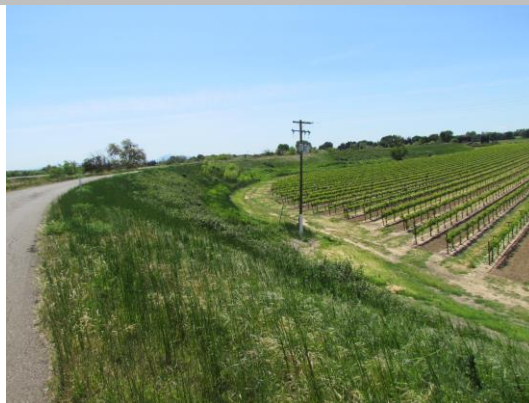
Photo 1 of 1 : SP_2015_RD0349_205_40_20150519_00316.jpg

Tall snap grass covering the landside slope.

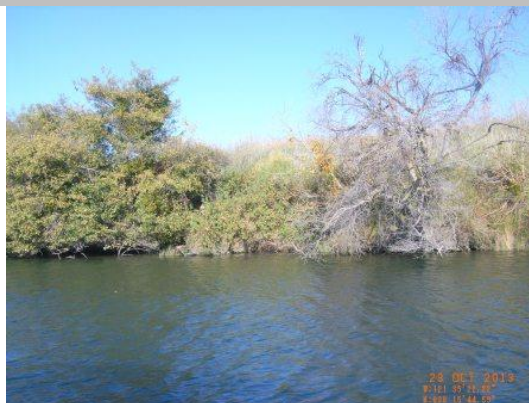
Photo 1 of 1 : SP_2015_RD0349_205_3_20150312_00004.jpg

LM Start	3.37	Rating **	M	Issue No.	3
LM End	3.49	Issue Type +	Ma	Location *	WS
Category	Supplemental			GPS Latitude/Longitude	
				Start	End
Item	USACE Erosion Survey			38.262510 °	38.262533 °
				-121.589481 °	-121.591690 °
DWR ID	DWR_RD0349_02_f_2014_3				
Action/Comments					
Inspector Comments: 2010 - Slumping sections on the lower bank, appears to be scouring around the trees. 2011 - Soil beach at toe. 2013: No observed changes. [2013 Site ID: STM_22-8_R]

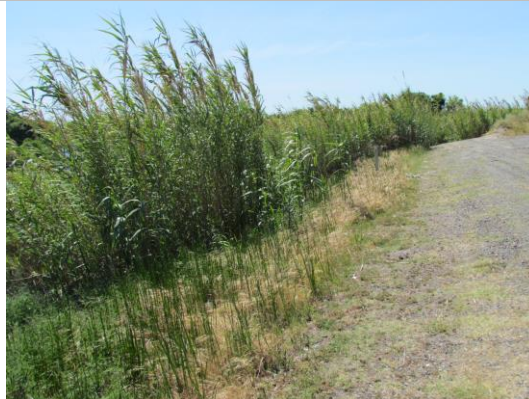
Photo 1 of 1 : SP_2015_RD0349_205_60_20150519_00319.jpg

Arundo on the waterside levee shoulder and slope.

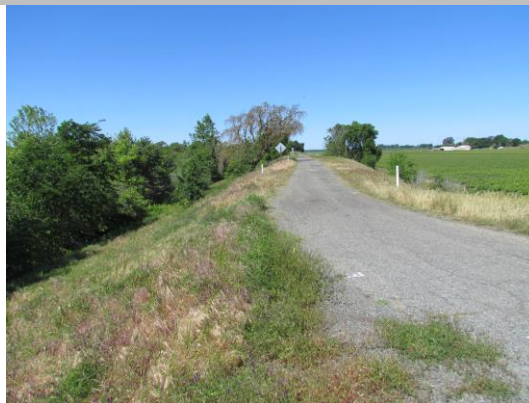
Photo 1 of 1 : SP_2015_RD0349_206_1_20150520_00355.jpg

Looking downstream from waterside at tall weeds.

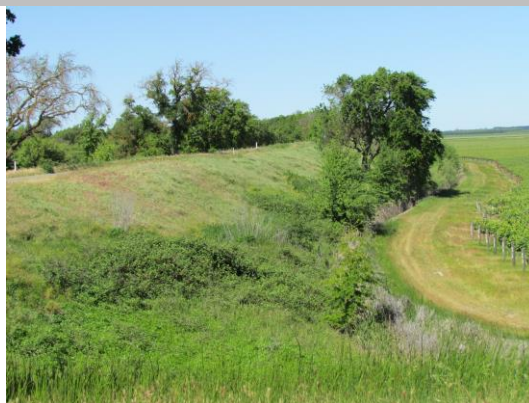
Photo 1 of 1 : SP_2015_RD0349_206_6_20150520_00353.jpg

View downstream at the landside slope with tall weeds and wild berries present on the levee slope and toe.

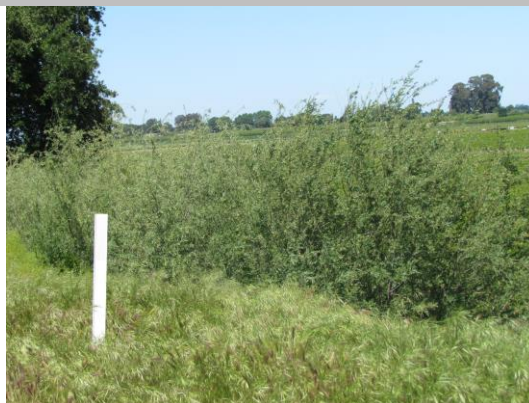
Photo 1 of 1 : SP_2015_RD0349_206_7_20150520_00354.jpg

Wild growth of trees and other vegetation on the landside slope and toe.

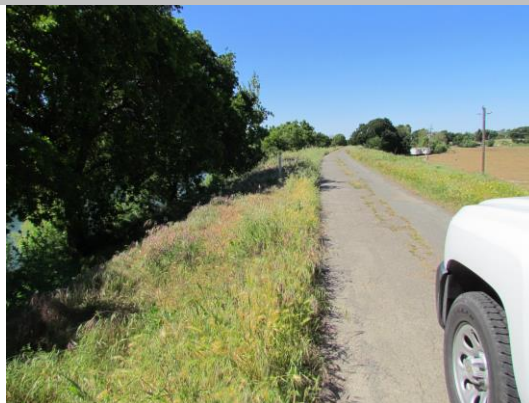
Photo 1 of 1 : SP_2015_RD0349_206_18_20150520_00358.jpg

Unacceptable tall weeds on the waterside shoulder and slope.

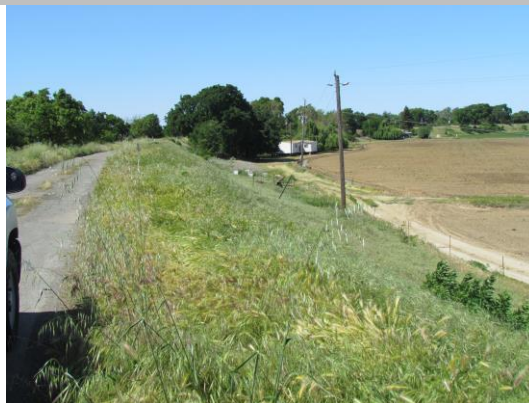
Photo 1 of 1 : SP_2015_RD0349_206_57_20150520_00359.jpg

Looking downstream of the landside shoulder and slope covered with tall weeds.

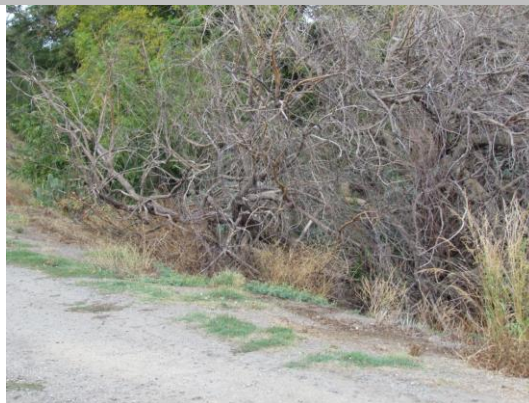
Photo 1 of 1 : SP_2015_RD0349_206_971_20150312_00017.jpg

Woody tree growth on landward levee slope.

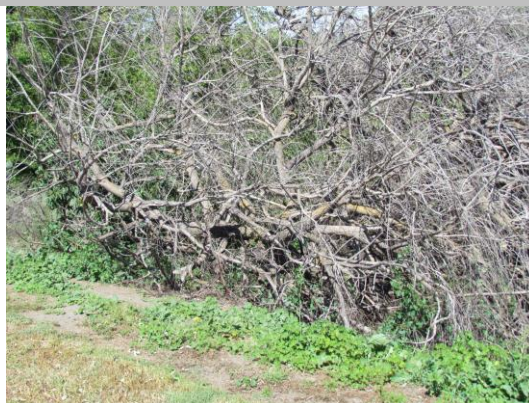
Photo 1 of 1 : SP_2015_RD0349_206_331_20150520_00360.jpg

Looking along the levee slope at a cluster of dead trees blocking the view of the levee and making it hard to do flood fight.

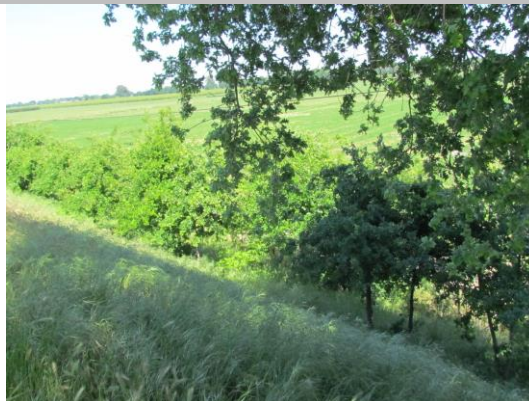
Photo 1 of 1 : SP_2015_RD0349_206_332_20150520_00361.jpg

Small oak trees present along the toe of the landside levee slope.

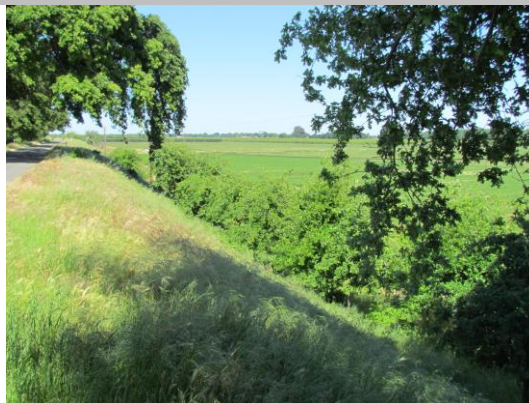
Photo 1 of 1 : SP_2015_RD0349_206_333_20150522_00363.jpg

Tall weeds on the landside levee slope and wild growth on the landside toe.

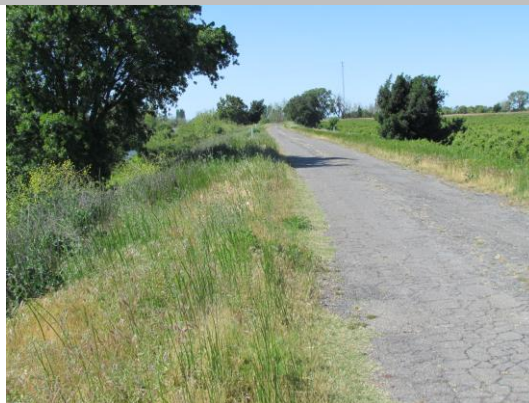
Photo 1 of 1 : SP_2015_RD0349_206_334_20150522_00364.jpg

View of unwanted tall weeds on the shoulder and slope of the waterside.

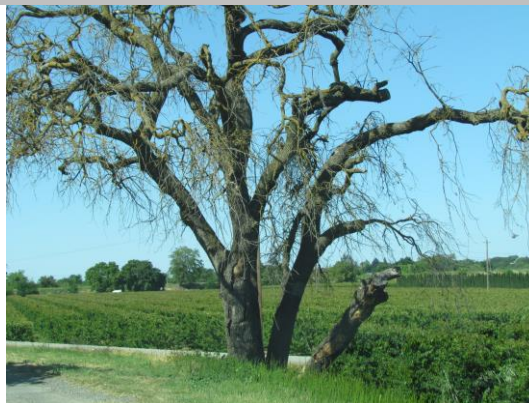
Photo 1 of 1 : SP_2015_RD0349_206_73_20150522_00365.jpg

Remove this dead tree from the landside levee slope. If it falls it will block the levee crown roadway.

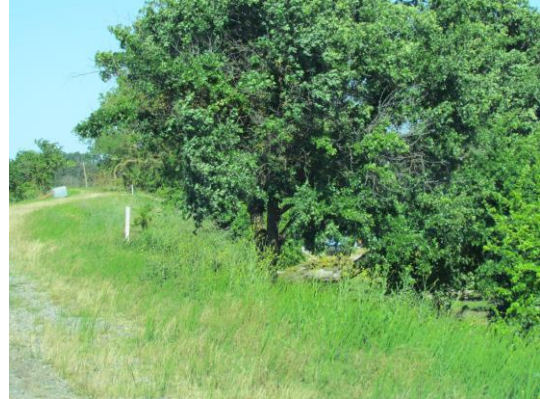
Photo 1 of 1 : SP_2015_RD0349_206_336_20150522_00366.jpg

Unsatisfactory tall weed growth on the landside levee shoulder and slope.

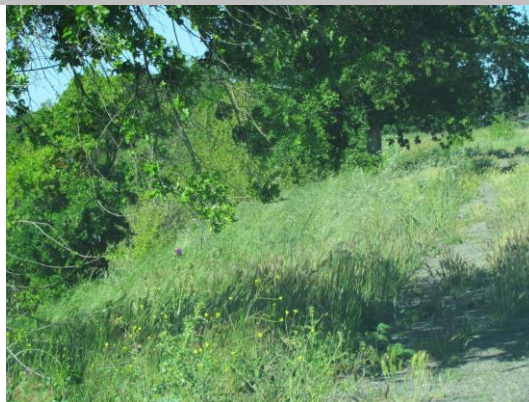
Photo 1 of 1 : SP_2015_RD0349_206_339_20150522_00367.jpg

View of unwanted tall weed growth on the waterside levee slope, shoulder, and crown roadway.

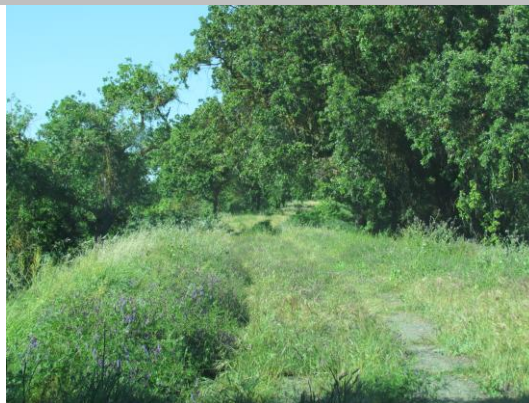
Photo 1 of 1 : SP_2015_RD0349_206_340_20150522_00368.jpg

Unacceptable tall weeds on the slopes and the crown roadway completely covered with tall weeds.

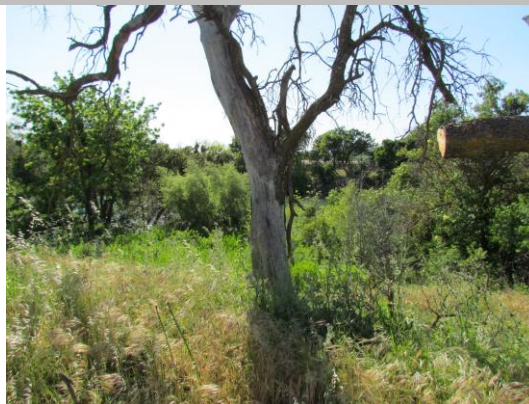
Photo 1 of 1 : SP_2015_RD0349_206_343_20150522_00369.jpg

Dead tree on the waterside levee slope that could fall and block access.
